TROUBLE LOOMS

Crossing the border from Russia to Kazakhstan, Paul and Helen begin to hear ominous noises coming from the Landy

Words and Pictures by Paul and Helen Crittenden

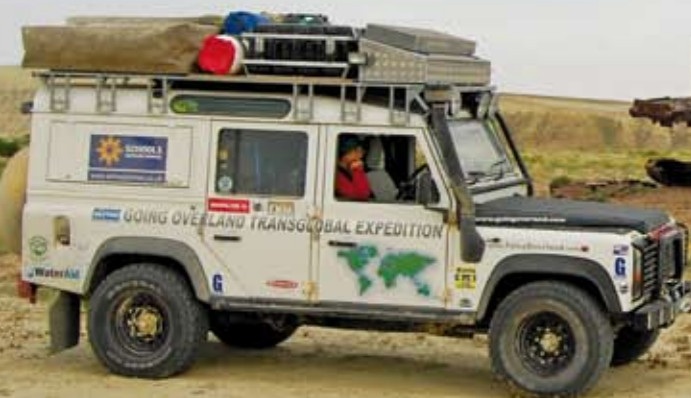
Above:
Dust was a serious problem, not helped by the many gaps and ineffective door seals.

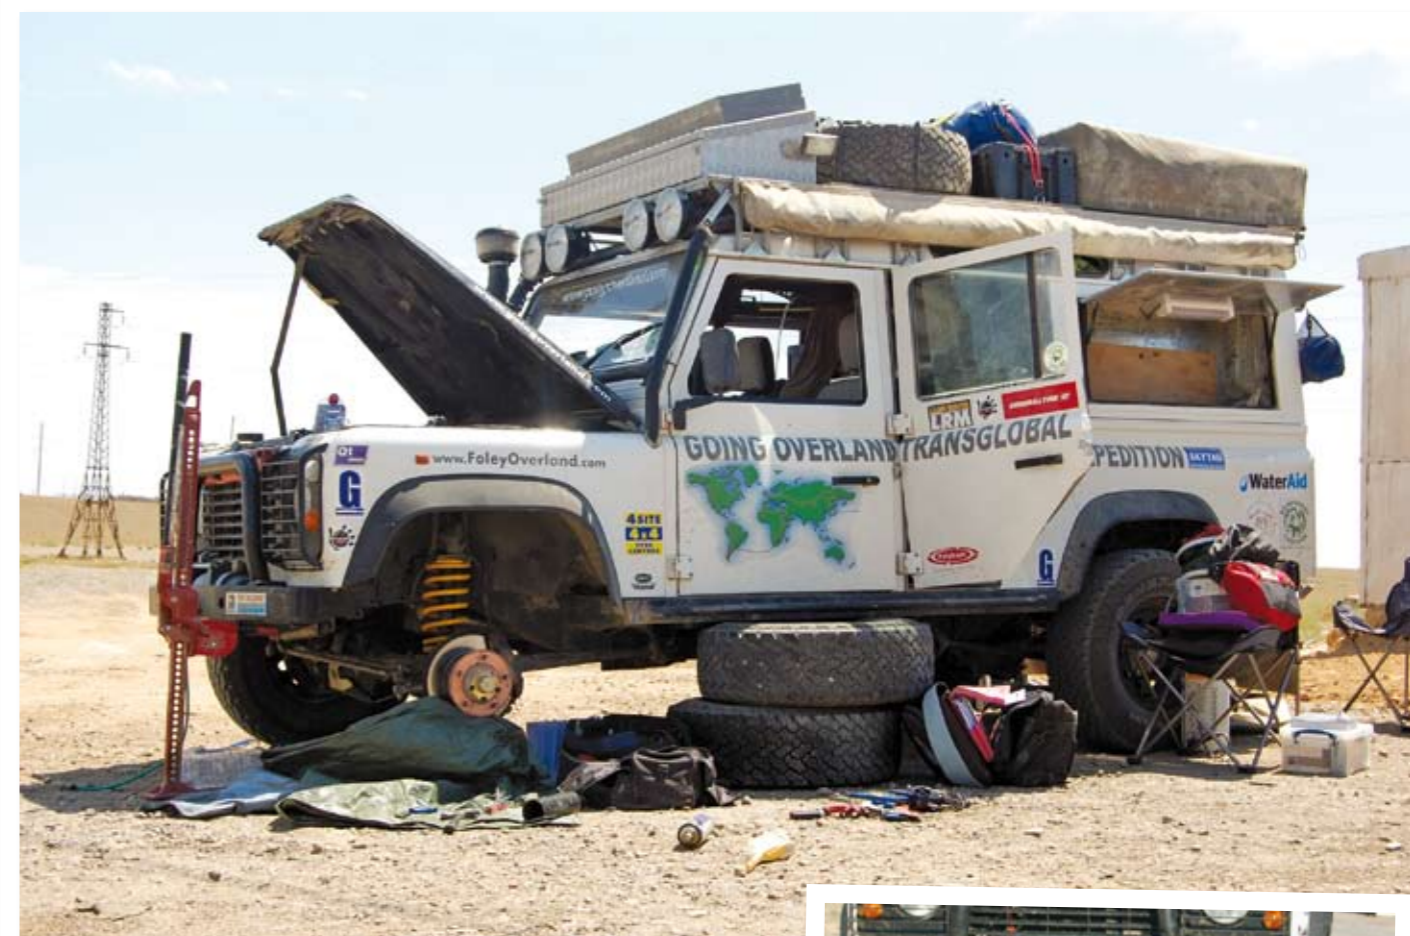
Above: Bodes by the Land Rover dealership in Stavrapol led to this – bushes fitted in the wrong place, with some parts missing altogether.

what was now a serious clanking sound when we stopped to remove the dead bodies of the huge crickets that had been swarming in front of us. We were shocked. The Land Rover Dealership in Stavrapol had incorrectly fitted the brand new Polybushes we had provided. Some parts were upside down, the rear suspension parts had been incorrectly fitted on the front, and some bits were missing altogether. The miracle is that the Polybushes themselves had, with only one exception, survived intact. The rest of the suspension system was completely and utterly shot. Hardly surprising with, in effect, no bushes in place.

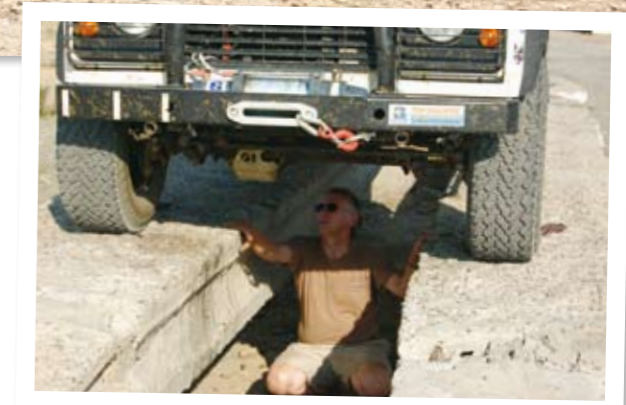
Additional damage to the threads on the top mountings were made worse by the helping hand of another lorry driver who, with the aid of brute force on the end of a hammer, had forcibly removed the shroud, rather than easing it off over a filed weld. The threaded section of the shock

Top: Repair stop at the Café Camel.

absorber was bent and the threads needed to be re-fettled.

To make matters worse, while making a die out of one of the nuts by producing a cutting edge on the thread and then re-cutting the threads on the shaft, Paul managed to slice his hand open with the hacksaw and so create our first real delve into our first aid kit.

Job done, we know the repair is only temporary and, on rough roads, still very vulnerable. We still need to take it easy. But that's only one problem.
